# FROM ARSON TO RECOVERY — JUST IN TIME FOR EASTER

First Presbyterian Church — Monticello, Iowa

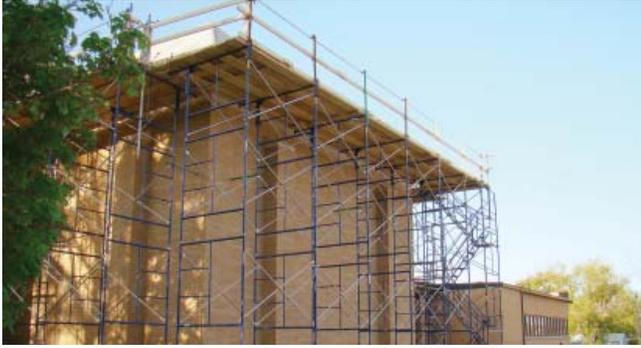
### THE MAJOR CHALLENGE: SMOKE AND ODOR CONTROL

Extensive soot residue was found between the roof decking and framing system, and we exposed an abandoned roofing system in the attic area. These areas could not be physically accessed to properly soda blast and seal them against smoke odor, so the team decided to replace them.

After soda blasting and sealing the entire interior, we still had a problem: in isolated areas a very faint smoke odor remained. Rather than hope that the odor dissipated over time, we proceeded with additional soda blasting before sealing the entire structure once more. Then the entire Building Committee conducted an official “sniff” test. The building passed.
